# OHIO HISTORIC INVENTORY

1. No. <b>LOR-02010-21</b>		4. Present Name(s) <b>Thourot House</b>		LOR-0201 0-21
2. County <b>Lorain</b>		5. Historic or Other Name(s) <b>Goodrich-Thourot House</b>

6. Specific Address or Location <b>182 East College</b>		19a. Design Sources		Lorain 2. County
6a. Lot, Section or VMD Number <b>900086109047</b>		20. Contractor or Builder

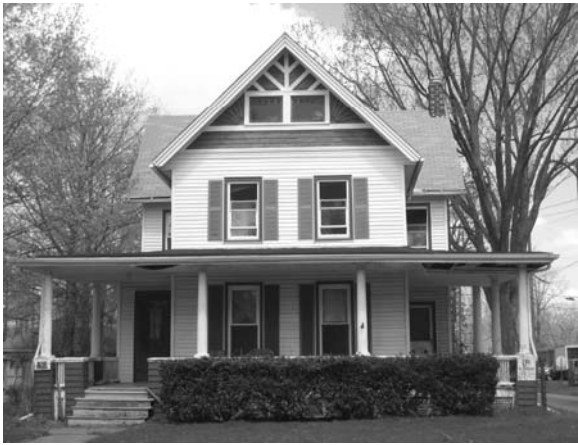
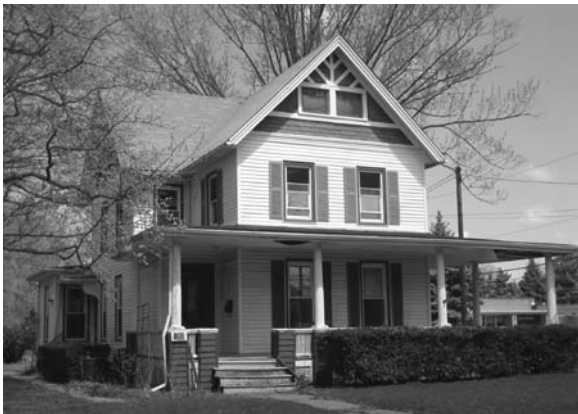
which is not recessed as far back as the right door, appears to have stained glass windows in the upper half of the wood door. Wooden steps up the front porch lead to this door. If the window does not have stained glass, the square glass windows have been tinted. The 1/1 double hung window above the door is set back farther than the door is. The west elevation is mostly obscured by foliage. The west-facing gabled section, near the center, has a door at the first story with a hood that has a decoratively-carved wood bracket. The bracket is somewhat S-shaped with wood carved in an almost-sunburst pattern. Two 1/1 double hung windows are to the right of the door. Left of the door, a projecting bay has a 1/1 double hung window facing the stoop that contains the decorative bracket and another 1/1 double hung window facing west. The east elevation has a decorative gable that is a simplified version of the south gable. The chimney runs up the center of the gable and is flanked by attic windows. Each window has muntins that create a row of three square lights in the upper portion of the window. Wood beams run diagonally to the eaves on each side of the windows. Left of the chimney at the first and second stories, there are 1/1 double hung windows. A small 1/1 double hung window is right of the chimney at the first story, while the second story has a small casement window. Left of the gabled portion of this elevation, at the porch, 1/1 double hung windows have shutters. Above the porch, another 1/1 window has shutters. A pair of casement windows is at the first story, right of the gabled portion of the elevation. Above this pair, in the second story, there is a 1/1 double hung window. The two-story addition at the rear of the house has a modern door to the left with a wood wheelchair ramp. The door is shaded by a shed hood. At the second story, a 1/1 window opens to a seemingly-insecure platform.
