OHIO HISTORIC INVENTORY

1. No. LOR-1594-21		2. County Lorain		4. Present Name(s)		1. No. LOR-1594-21
3. Location of Negatives O.H.I.O. Resource Cen						
Roll No. 17		Picture No.(s) 02, 03		5. Historic or Other Name(s) Hall House		2. County Lorain

6. Specific Address or Location 581 East College Street		16. Thematic Associations: Furniture, ,		28. No. of Stories Two story		
6a. Lot, Section or VMD Number 0900-088-105-043		17. Date(s) or Period c. 1890-1900	17b. Alteration Date(s)	29. Basement? Yes		4. Present or Historic Name(s)

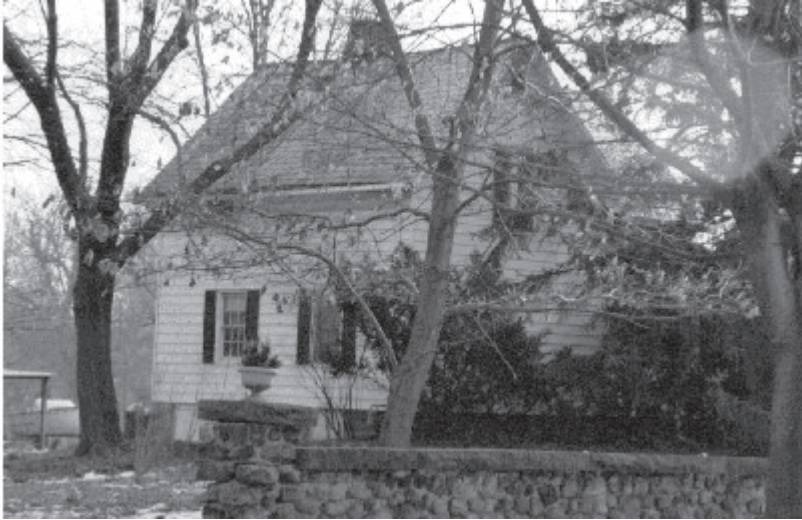
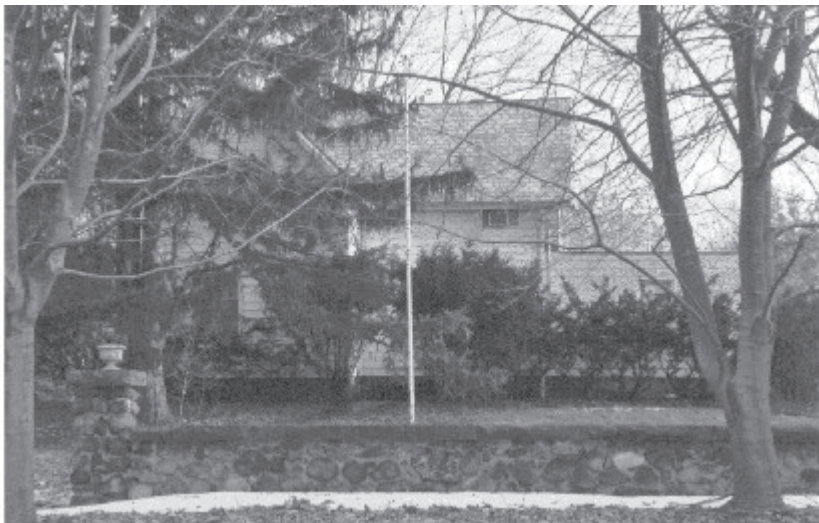
1. No. LOR-1594-21	2. County Lorain	4. Present Name(s)	1. No. LOR-1594-21
3. Location of Negatives O.H.I.O. Resource Cen			
Roll No. 17	Picture No.(s) 02, 03	5. Historic or Other Name(s) Hall House

26. Property Acreage .39		40. Chimney Placement Center		
		27. Other Surveys		41. Distance from & Frontage on Road Approx. 40'		
42. Further Description of Important Interior and Exterior Features (Continued on Reverse if Necessary)						5. Specific Address or Location 581 East College Street
<p>The front elevation of this much-altered vernacular gabled ell house has a front-facing gabled section with a one-over-one window in the first story and another in the second story. A door to the right of the projecting section has a window in the upper half and two molded wood panels below. Two small, rectangular windows run below the roof, and may have appeared more like frieze windows, before alterations were made to the exterior siding. An continued...</p>

addition to the right has one window and a flat roof. The northwest elevation has the one-story addition visible, with a set of three windows with shutters. A door in the second story leads to the roof of the addition. At the southeast elevation, a small window is located at the far left of the second story. The first story has two six-over-six windows with shutters. The basement has a garage door and another door to the right. The gutter is falling from the eave at this elevation. In general, the house is heavily obscured by foliage.
