OHIO HISTORIC INVENTORY

1. No. LOR-02148-21		4. Present Name(s) Dennis Chan and Meredith Bradley House	
2. County Lorain		5. Historic or Other Name(s) Unknown	
6. Specific Address or Location 46867 West Hamilton		19a. Design Sources	35. Plan Shape Rectangular
6a. Lot, Section or VMD Number 0900104000009		20. Contractor or Builder	36. Changes associated with 17/17b Dates: 17. Original/Most significant construct

Dennis Chan and Meredith Bradley House
4. Present or Historic Name(s)

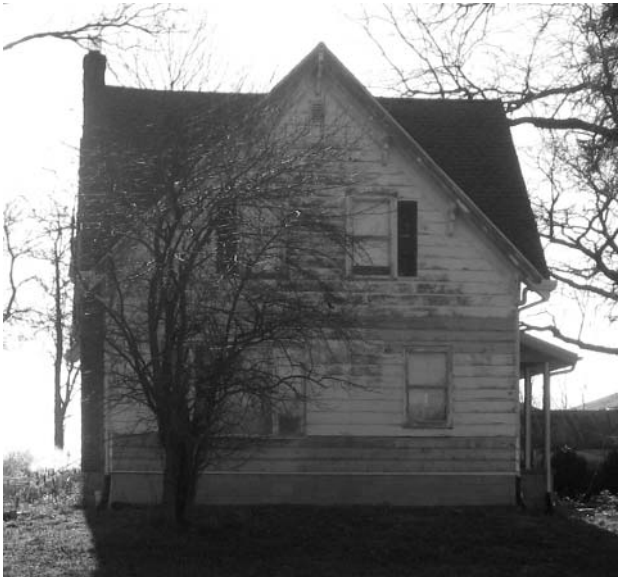
This vernacular cross gable home has a strong Italianate element in its scrolled brackets below the roof's eaves. The house has a boxy shape, with a centered gable facing the front/north facade. However, the front gable's roof intersects into the cross gables that extend symmetrically to the east and west. The house is partially obscured by foliage, and the windows have shutters, which are not original. The first story has a picture window at the left flanked by a vertical row of five sidelights on each side. A window at the right is double double hung, with shutters. The second story has two 1/1 double hung windows with shutters on the outer sides of the window only. The gable features a vent. The west elevation appears to have two replacement 1/1 double hung windows at the first story and a double hung window in the gable. According to the owners, part of the house was removed and a new addition is being added to the back of this house. The west elevation of the new addition has are three new double hung windows and a door at the first story, within a simple porch, and two gabled dormers above. To the south of that is a west-facing gabled section with what continued...

look to be another new door and window. At the south elevation, a pair of windows is at the right, and a large window is at the left. At the southeast corner of the east elevation, the house is obscured; however, a one-story wing is just visible.
