# OHIO HISTORIC INVENTORY

1. No. LOR-1825-21		2. County Lorain		4. Present Name(s)		1. No. LOR-1825-21
3. Location of Negatives O.H.I.O.						
Roll No. 3		Picture No.(s) 14,15		5. Historic or Other Name(s) Nord House		2. County Lorain

6. Specific Address or Location 23 Hawthorne Street		16. Thematic Associations: Machinery, EDUCATION, Governmental Administrat		28. No. of Stories Two story		
6a. Lot, Section or VMD Number 0900084108001		17. Date(s) or Period c. late 1950's		17b. Alteration Date(s) 1974 (Property Card)		4. Present or Historic Name(s)

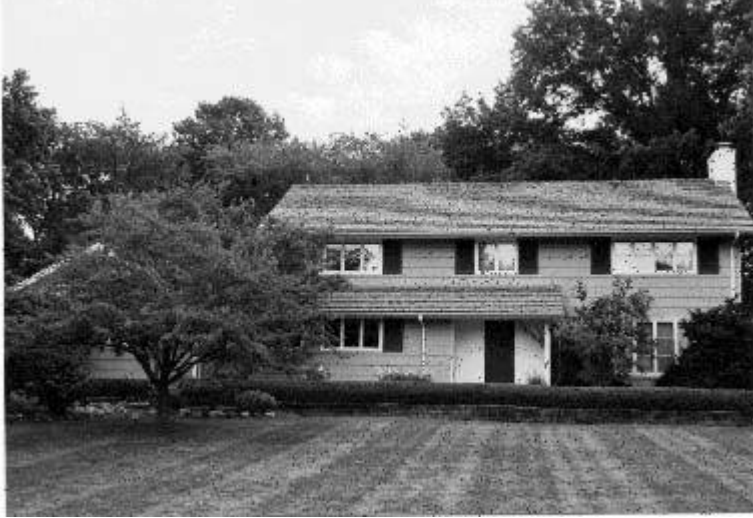
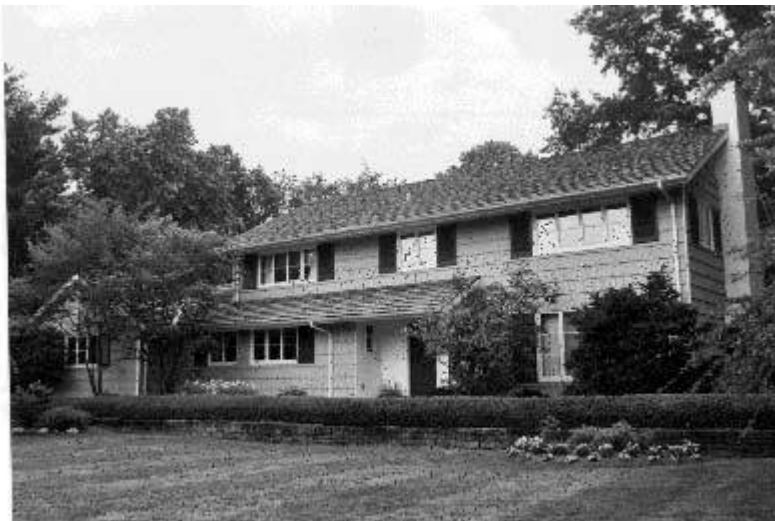
28. Further Description of Important Interior and Exterior Features (Continued on Reverse if Necessary)		40. Chimney Placement Multiple random		
		<p>This beautiful two-story vernacular home contains a three-paneled wood front door, which is situated in the center of the front facade and slightly recessed. A small shed roof hangs over the entry way and a small enclosed section that projects out from the facade on the left. Five windows are arranged on the small section in groups of two and three, and shutters are located on the outside edge of each group of one-over-one double hung windows. continued...</p>		41. Distance from & Frontage on Road Dist: 25' & Frontage: 190'

Four triple hung windows are situated on the right side of the front door and contain shutters. Several more windows with shutters are located in the second story, as two paired windows rest above the door and are flanked by four side-by-side windows on each side. A projecting gable is located on the left side of the front elevation and contains three windows. The north elevation indicates that the gabled section is a two-car attached garage with a door positioned to right that has two small windows on top. Two windows are located on the gable end axis of the main body as well as a vent underneath the roofline. Another entry is recessed back under the eave of the roof to the left of the garage. Two large stained glass windows are located on each side of the door. Continuing down the facade are windows in groups of two, three and one. The last window appears to be a casement window, while the others appear to be arranged as a casement window situated above an either awning or hopper window. A skylight is located above the two windows in the gabled roof. A brick painted chimney is situated within the roof surface of the gabled section. While another brick painted gable end, exterior chimney is located on the south elevation between two sets of windows on the second story that are like those on the front facade positioned above the front door. The south elevation reveals a variety of windows in several layouts located on the gabled section that stretches out behind the house creating an L-shape plan. The brick foundation is visible on the north elevation and according to the Lorain County Auditor's property card; the house also contains a basement.
