OHIO HISTORIC INVENTORY

1. No.	2. County LOR	4. Present Name(s) #38 Pauly's Pizza; #40 Moderne Beauty Shop; #42 The Oberlin News-Tribune; 2nd Floor: Solaluna <input type="checkbox"/> Coded

6. Specific Address or Location 38, 40, 42 South Main Street		30. Foundation Material Stone													
6a. Lot, Section or VMD Number 09-00-085-112-054		31. Wall Construction Brick

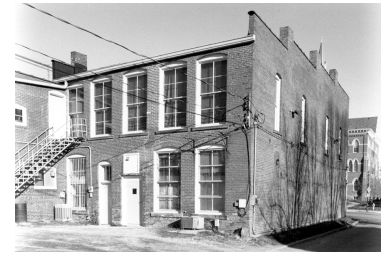
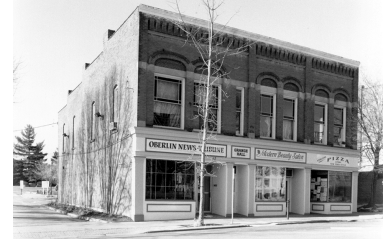
42. Further Description of Important Interior and Exterior Features This two story Victorian commercial building has three first floor storefronts. Brick piers divide the facade into two sections. There is sandstone trim and a stone band above the 2nd floor windows. The windows are double hung sash with colored glass panes around the central square expanse of glass. Brick herringbone pattern with segmental arches above the 2nd floor lintel band. There is brick corbeling at the cornice level. The southern wall is unpainted brick with segmental arched windows on the second floor and filled window openings on the first; star iron tie rods.

43. History and Significance The northern third of this building was built in 1877, John D. Carpenter remodeled it in 1895 adding the two southern storefronts. The rear view clearly reveals that the different sections were built at separate times. In 1919 the Grange purchased the building; their organization operated (meetings and offices) on the second floor and rented the lower storefronts. The first floor storefronts were occupied by many different businesses until the 1930s when the Oberlin Food Store (1937) opened in #40 and the Ohio Fuel Gas Co. (1935) in #42. The upper floors were vacant for some time, a new business, a Yoga and Health Studio, opened in late 1999.
