OHIO HISTORIC INVENTORY

1. No. LOR-1846-21		2. County Lorain		4. Present Name(s)		1. No. LOR-1846-21
3. Location of Negatives O.H.I.O.						
Roll No. 1		Picture No.(s) 14,15,16		5. Historic or Other Name(s) Wheeler-Holl House		2. County Lorain

5. Historic or Other Name(s)
Wheeler-Holl House

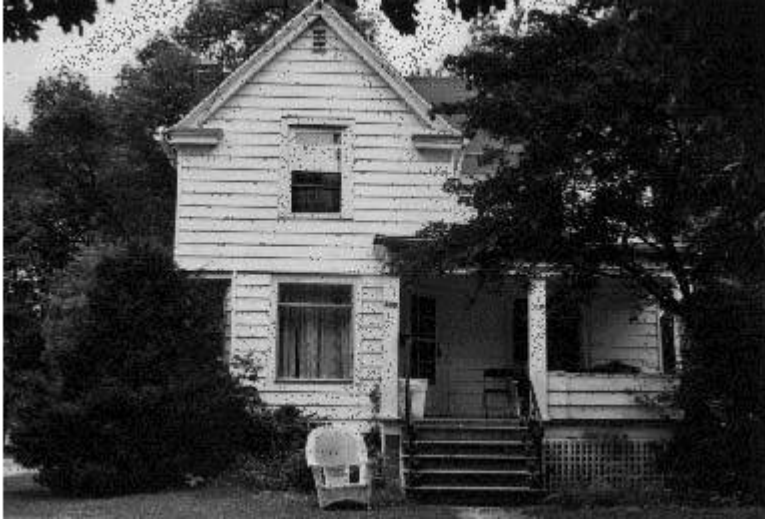
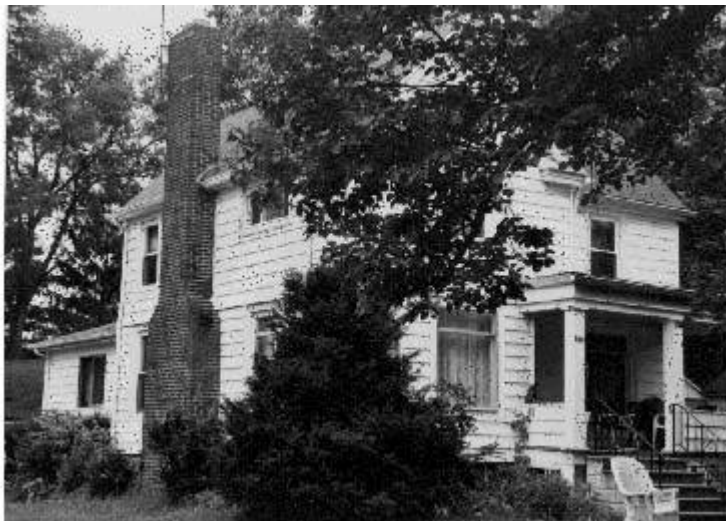
L^{No}
LOR-1846-21

41. Distance from & Frontage on Road Dist: 30' & Frontage: 100'		
42. Further Description of Important Interior and Exterior Features (Continued on Reverse if Necessary)						6. Specific Address or Location 380 S. Main Street
<p>This vernacular house has a porch at the right two-thirds of the first story and a large double hung window is located left of the porch; the window's upper pane is about one-third the size of its lower pane. Above the window, in the second story, is a one-over-one double hung window. A vent is located in the attic gable. The porch has square supports and a wall covered in aluminum siding. Cement steps lead up the porch and have a metal rail. The continued...</p>

<p>51. Condition of Property: Good/Fair</p> <p>52. Historic Outbuildings and Dependencies Historic Garage</p> <p>53. Affiliated OAI Site Numbers</p> <hr/> <p>Door Selection: Single off center</p> <p>Door Position: Recessed</p> <p>Orientation: Gable with two story same height</p> <p>Symmetry: Bilateral asymmetry</p> <hr/> <p>FOR OHPO USE:</p> <p>49. Revised By:</p> <p>50a. Date Revised:</p> <p>50b. Reviewed by:</p> <p>RPR Number:</p>	<p>54. Farmstead Plan</p> <div style="border: 1px solid black; height: 250px; width: 100%;"></div>
--	--

door is situated on an angle, near the center of the elevation with a double hung window to the right. The window to the right of the door also has a smaller upper pane than lower pane. A smaller, one-over-one double hung replacement window is located in the second story. The far left side of the second story juts out above the first story's cut-away bay. The front-facing gable in the left half of the elevation has cornice returns. The north elevation has a large one-over-one double hung window at the first story and a smaller window to its right. The second story features two one-over-one double hung windows. The first story addition at the rear has two one-over-one double hung windows. The south elevation contains additions. Two one-over-one double hung replacement windows are located in the first story, and are separated by the brick chimney. The second story has small, sliding windows.
