# OHIO HISTORIC INVENTORY

1. No. LOR-1716-21		2. County Lorain		4. Present Name(s)		1. No. LOR-1716-21
3. Location of Negatives O.H.I.O. Resource Cen						
Roll No. 11		Picture No.(s) 23,24		5. Historic or Other Name(s) Morris House		2. County Lorain

9. U.T.M. Reference Quadrangle Name: Oberlin 17 398017 4571086 Zone Easting Northing		19. Architect or Engineer		31. Wall Construction Balloon frame/western frame/pla

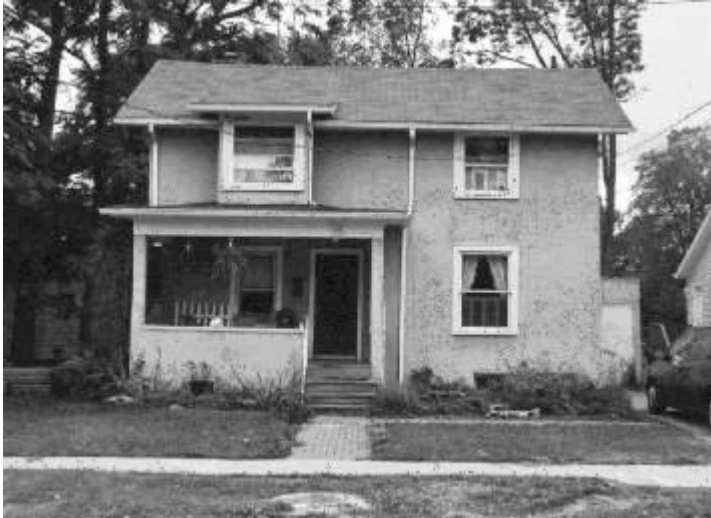
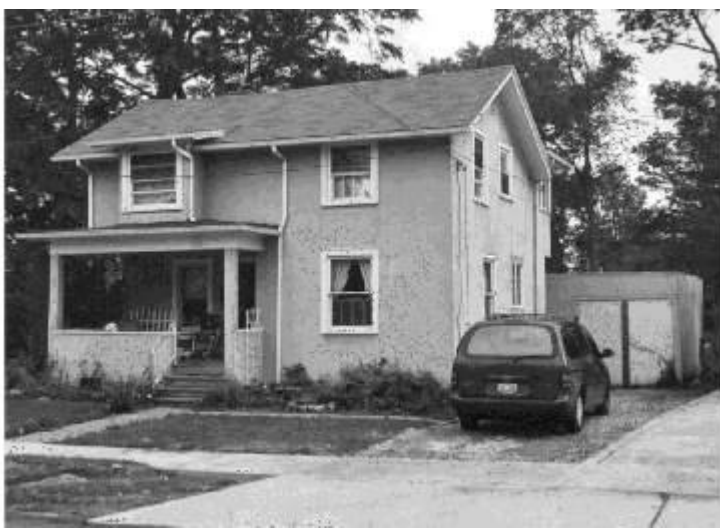
Roll No. **11** | Picture No.(s) **23,24**

41. Distance from & Frontage on Road Approx. 15'		
42. Further Description of Important Interior and Exterior Features (Continued on Reverse if Necessary)						6. Specific Address or Location 15 Morgan Street
<p>This vernacular home appears to have undergone a few alterations, which make the original style difficult to determine. The exterior of the house is covered in rough stucco, with virtually no ornament. The front porch extends from the center of the elevation to the left, with square supports and a wall, both covered in stucco. Cement steps lead to the porch, as well as an iron railing. The wall below the porch is slightly recessed from the continued...</p>

remainder of the house. The door is located near the center of the elevation, with a one-over-one window to the left. Above the very low, hip roof of the porch, a projecting bay contains a one-over-one window that extends into a wall dormer with a shed roof. One-over-one windows are located to the right of the porch at the first and second stories. The west elevation contains a one-over-one window at the left side of the first story, with a pair of casement windows to the right. The second story has one-over-one windows; the left window is larger. A louvered vent is located in the gable. At the far right of the elevation, the second story projects at the rear of the house and has corner windows. The east elevation contains two one-over-one windows in the second story and a louvered vent in the gable. A one-over-one window at the center of the first story, below the projecting second story.
