OHIO HISTORIC INVENTORY

LOR-1918-21

Seventh Day Adventist Church 4. Present or Historic Name(s)

99 South Park 6. Specific Address or Location

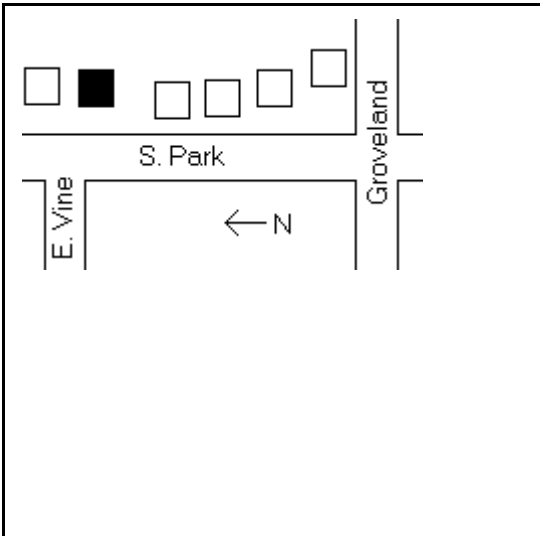
8. Site Plan with North Arrow

44. Description of Environment and Outbuildings (See #52)
This church is located on a residential street. The lot includes a small parking lot to the south of the building.

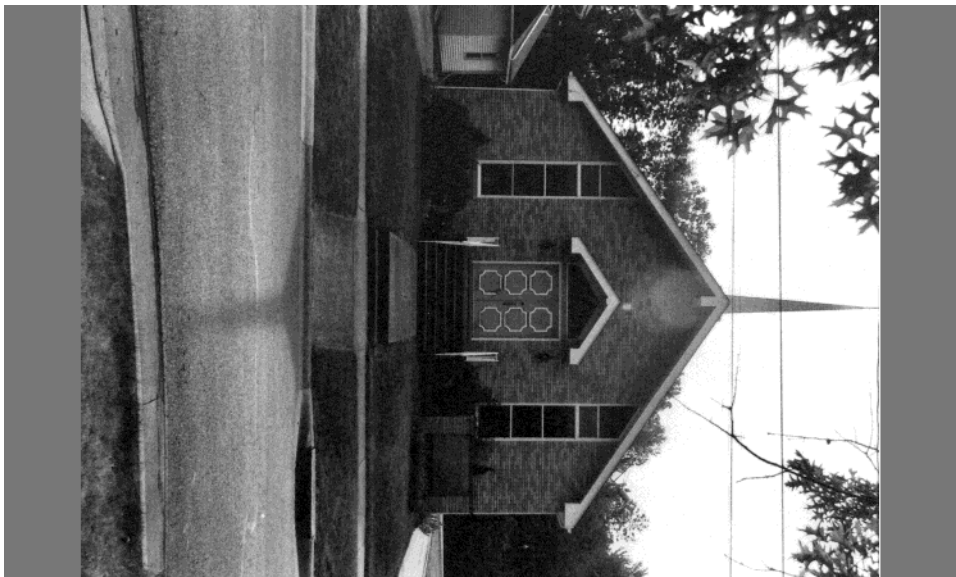
42. Further Description of Important Interior and Exterior Features (Continued on Reverse if Necessary)
This Contemporary-style church is composed of a combination of brick and stucco. The main (west) facade is brick, with centrally-located concrete steps and iron railings leading to double doors. Each door has three panels with a decorative wood overlay of squares with concave corners, almost creating a cross shape. A triangular hood covers a triangular transom with a blurred glass pane. The lines of the hood are parallel with those of the roof, and the box cornices and exposed rafters in the peak of the gable echo those of the roofline. On either side of the doors, long, narrow blue textured glass windows extend down from the roofline to a few feet above the ground. Muntins divide these windows into five panes; one pane in the window at left has been replaced with plain blue glass. The wood steeple, located along the ridgeline toward the front gable, is triangle-shaped, narrowing to a point with a cross at the top. The south elevation contains 1 1/1 double hung window in the small brick portion at left. Most of the elevation is stucco, and divided into 5 bays by 4 stepped buttresses, though the steps are rounded. Each bay contains a 1/1 double hung window, with continued...

**a side door in the far left bay. The north elevation largely mirrors the south, except instead of the side door, a small entry with a gable roof and west-facing door juts out between the fourth buttress and fifth bay.**
