OHIO HISTORIC INVENTORY

1. No. LOR-1856-21		2. County Lorain		4. Present Name(s)		1. No. LOR-1856-21
3. Location of Negatives O.H.I.O.						
Roll No. 1	Picture No.(s) 6,7	5. Historic or Other Name(s) Shanks-Wall-Wahl House

46. Prepared By: Clark, Surovy, Tomazic, Tuohy		47. Organization: O.H.I.O./Oberlin Heritage Center		48. Date Recorded: 08/02/2004

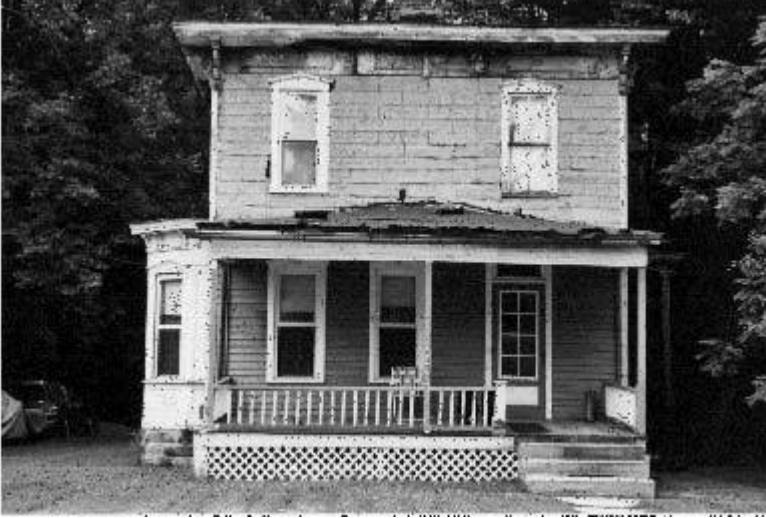
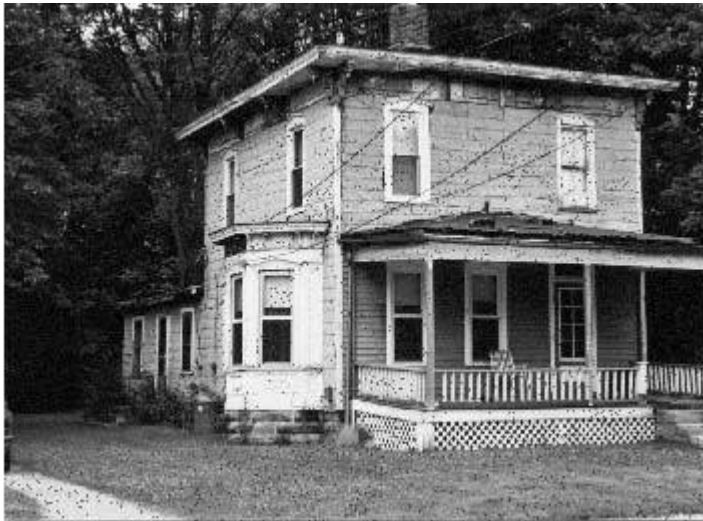
Roll No. **1** | Picture No.(s) **6,7**

26. Property Acreage .25		40. Chimney Placement Center		
		27. Other Surveys		41. Distance from & Frontage on Road Dist: 20' & Frontage: 66'		
42. Further Description of Important Interior and Exterior Features (Continued on Reverse if Necessary)						
<p>This two story, side hallway Italianate home can be entered from an eight-paned door located on the right side of the front elevation. Two one-over-one, double-hung windows are situated on the left side. Most of the windows on the house are one-over-one, double hung and adorned with a triangular pediment. Many of the windows appear to be replacements. Stone steps lead up to the full-width covered porch that is supported by three columns. A continued...</p>

44. Description of Environment and Outbuildings (See #52)						
<p>The house is situated on east side of S. Pleasant St. and is the third house from the intersection of Edison St. and S. Pleasant St. A garage is not located on the property. The house is in a state of disrepair, but is surrounded by homes that have been well maintained.</p>

balustrade runs along the perimeter of the porch. Brackets and bracketed cornices, typical of the Italianate style, are located under the low-pitched, pyramidal roof. The south elevation appears to contain several windows and a small covered porch with an entrance into the house. The south elevation is obscured by a lot of foliage. A bay window situated on the stone foundation is located on the north elevation and contains three windows and decorative brackets at the top. Another window is to the left of the bay window and two windows are located above these in the second story. The north elevation indicates a rear one-story addition that contains two windows with a door in the middle and a flat roof that begins to slope upward. A brick chimney is located in the center of the house.
