# OHIO HISTORIC INVENTORY

1. No. <b>LOR-1964-21</b>		4. Present Name(s)		LOR-1964-21
2. County <b>Lorain</b>		5. Historic or Other Name(s) <b>West House</b>		
6. Specific Address or Location <b>365 South Pleasant</b>		19a. Design Sources		Lorain
6a. Lot, Section or VMD Number <b>0900096113005</b>		20. Contractor or Builder

46. Prepared By: <b>Patricia Murphy</b>		47. Organization: <b>Oberlin Heritage Center</b>		48. Date Recorded: <b>12/05/2006</b>
49. PIR Reviewer:				50. PIR Review Date:

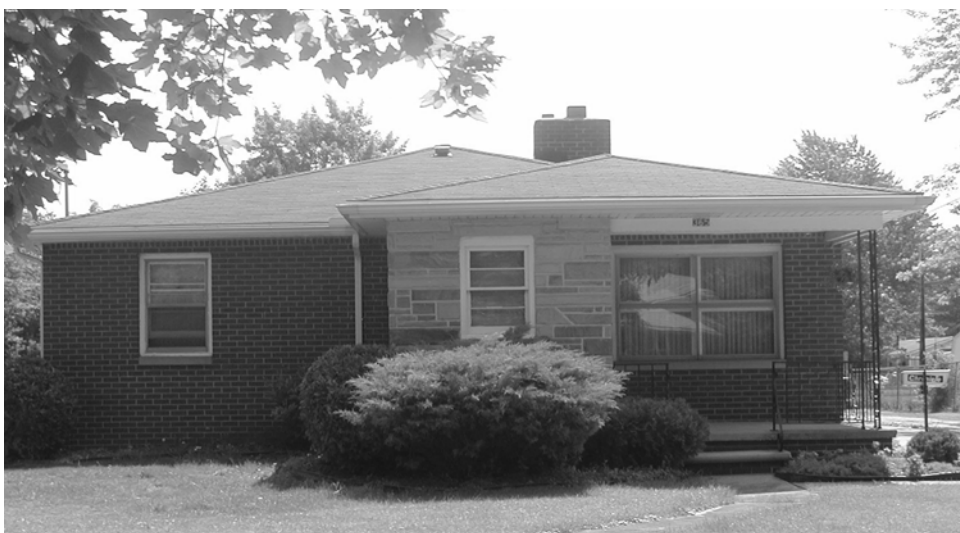
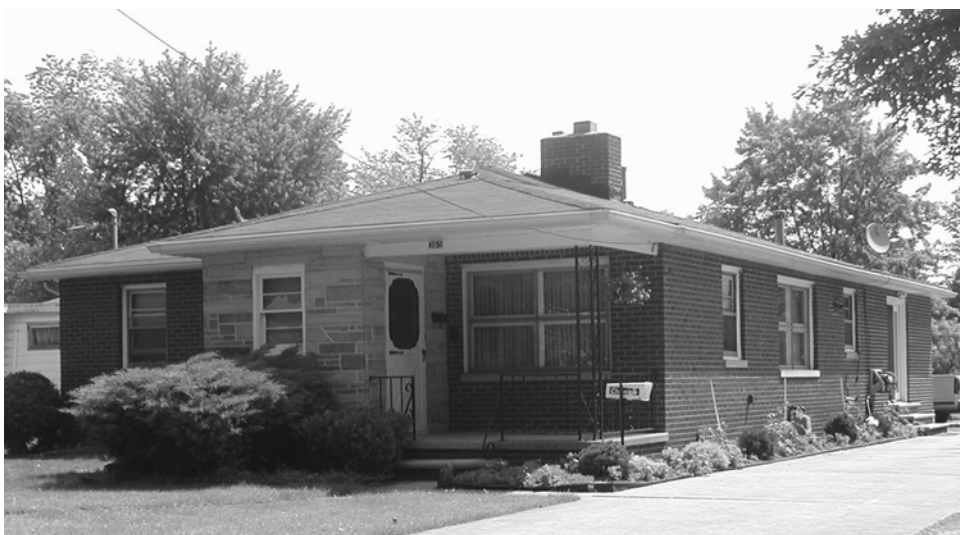
53. Affiliated Inventory Numbers Historic (OHI) Archaeological (OAI)				
42. Further Description of Important Interior and Exterior Features (Continued on Reverse if Necessary) <b>This simple, yet perfectly unaltered post-WWII, GI housing-style ranch house has elements of Colonial Revival style. According to the Lorain County Auditor's website, the house was built in 1954. A porch at the right corner of the main (west) facade is recessed under a small, hip roof, which copies the roof in the main body of the house. The porch has scrolling, metal supports and rails around the perimeter, as well as leading up to the porch. The steps and porch have a brick base, and cement caps. The door faces south within the porch, at a portion that is not recessed. Within the porch, a large window has one vertical and one horizontal muntin, dividing the window in to four squares. Left of the porch, in the projecting, ashlar stone portion, there is a 2/2 window (each sash has a horizontal mullion). Every visible window in the house has a cement sill except for this window. Also in this projecting section, there is a small, octagonal window that faces north and has horizontal mullions. At the far left, at the main body of the house (not projecting), there is another 2/2 window. The north elevation has four evenly-spaced, 2/2 windows. At the far left, another continued...</b>

1. No. <b>LOR-1964-21</b>	4. Present Name(s)
2. County <b>Lorain</b>	5. Historic or Other Name(s) <b>West House</b>
<p><i>42. Further Description of Important Interior and Exterior Features (Con't)</i></p> <p><b>window is smaller, rectangular, and is set high in the wall. The south elevation has a 2/2 window to the far left and left of center, a large window has one vertical and one horizontal muntin, creating four squares in the window. Right of center, there are 2/2 windows. At the far right, there is a sliding glass door, with brick steps leading up to it and cement caps.</b></p>	
<p><i>43. History and Significance (Con't)</i></p>	
<p><i>44. Description of Environment and Outbuildings (Con't)</i></p>	
<p><i>45. Sources (Con't)</i></p>
