# OHIO HISTORIC INVENTORY

1. No.	2. County <b>LOR</b>	4. Present Name(s) Talcott Hall		<input type="checkbox"/> Coded												
3. Location of Negatives O.H.I.O. Resource		5. Historic or Other Name(s) Talcott House														
<table style="width:100%; border-collapse: collapse;"> <tr> <td style="width:10%;">Roll #</td> <td style="width:10%;">Exp. #</td> <td style="width:10%;">Facing</td> <td></td> </tr> <tr> <td>E. Side 3</td> <td>34A</td> <td>W</td> <td></td> </tr> <tr> <td>Front 3</td> <td>33A</td> <td>SW</td> <td></td> </tr> </table>		Roll #	Exp. #	Facing		E. Side 3	34A	W		Front 3	33A	SW				
Roll #	Exp. #	Facing

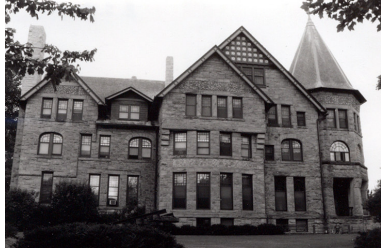
42. Further Description of Important Interior and Exterior Features This three-and one-half-story, split-faced ashlar sandstone, dormitory is an example of the Queen Anne Style. The roof has multiple gable ends along an L-shaped footprint. A six-sided, steep pitched, cone roof with finial towers is above the three-sided main entrance on the northeast corner of the building. A flight of steps leads to the main entrance porch emphasizing the building's high foundation. The main entrance double doors have a pattern of small square lights surrounding a central expanse of clear glass and a transom that repeats the pattern. Decorative elements include thick bands of carved stone leaves and flowers spanning the gable ends, and decorative woodwork along the edge of the gable end. The windows of the first story are longer than (cont.)

those on the other stories; all windows are double-hung. The top lights of the windows of the first floor common rooms have leaded, stained glass, while the others have multi-paned clear glass. The rear of the building lacks the details found on the front. The interior has a dining hall and multiple grand staircases. Some of the original ash woodwork still exists in the moldings around doors and windows. This building has been maintained with regular renovations.
