OHIO HISTORIC INVENTORY

1. No. LOR-1595-21		2. County Lorain		4. Present Name(s)		1. No. LOR-1595-21
3. Location of Negatives O.H.I.O. Resource Cen						
Roll No. 16		Picture No.(s) 09, 10		5. Historic or Other Name(s) Hungate House		2. County Lorain

6. Specific Address or Location 691 East College Street		16. Thematic Associations: Music, ,		28. No. of Stories One and a half story		
6a. Lot, Section or VMD Number 0900-088-103-005		17. Date(s) or Period c. 1940		17b. Alteration Date(s)		4. Present or Historic Name(s)

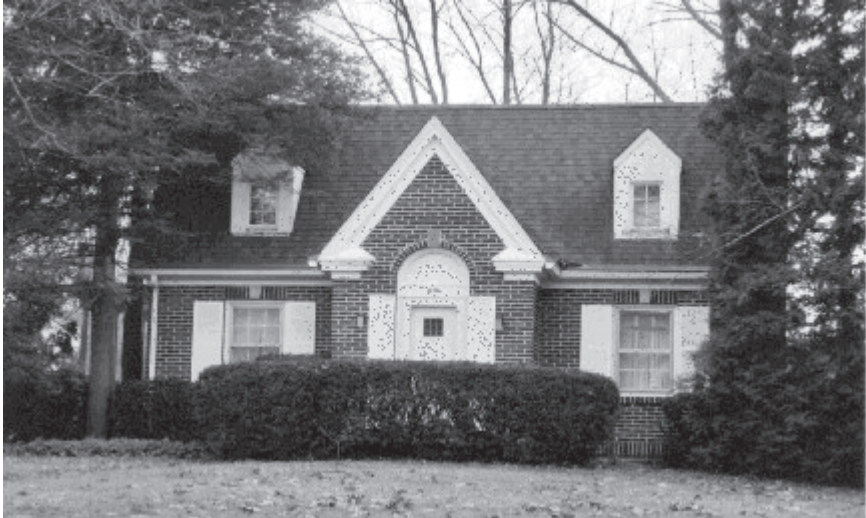
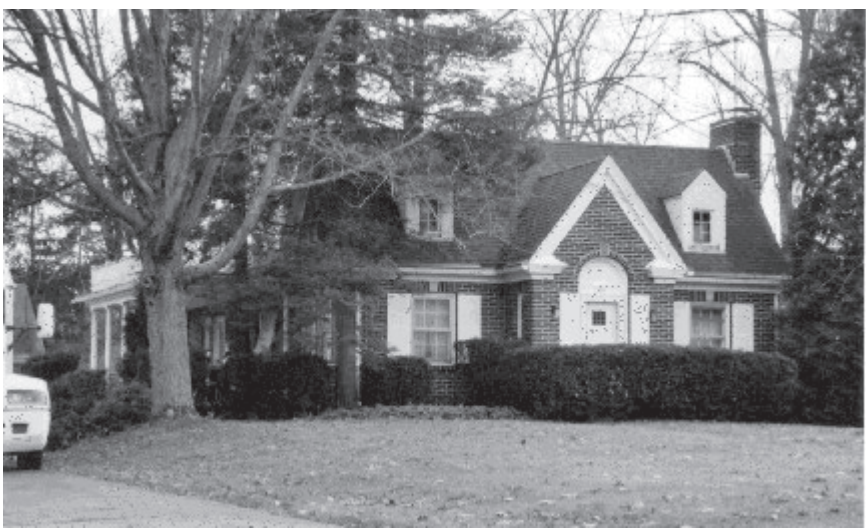
41. Distance from & Frontage on Road Approx. 40'		
42. Further Description of Important Interior and Exterior Features (Continued on Reverse if Necessary)						6. Specific Address or Location 691 East College Street
<p>This Colonial Revival, Cape Cod house has a central gabled entry, which projects from the house. The door has a square window in it and shutters surround it. A filled fanlight is located above the door and a brick arch with a keystone follows the arch. The gable above the door has a cornice below and returns. At the left and right of the door are six-over-six windows with shutters. Keystones are located above the first story windows. The second continued...</p>

story features gabled dormers with six-panel casement windows. At the east elevation, a two-story porch has Tuscan columns at the first story. A door is located left of center, and simple posts are in the balustrade of the second story porch. A set of three windows are located in the first story, with obscured, arched windows in the second story. The west elevation has a wing that extends from the rear of the house, and the windows at this elevation have shutters. The majority of the side elevations are obscured by trees and other vegetation.
