OHIO HISTORIC INVENTORY

1. No. LOR-1608-21		2. County Lorain		4. Present Name(s)		1. No. LOR-1608-21
3. Location of Negatives O.H.I.O. Resource Cen						
Roll No. 10		Picture No.(s) 13,14		5. Historic or Other Name(s) Belden House, Junto House Dormitory		2. County Lorain

8. Site Plan with North Arrow		18a. Style of Addition or Elements(s) Dutch Colonial Revival		31. Wall Construction Balloon frame/western frame/pla		6. Specific Address or Location 287 West College Street

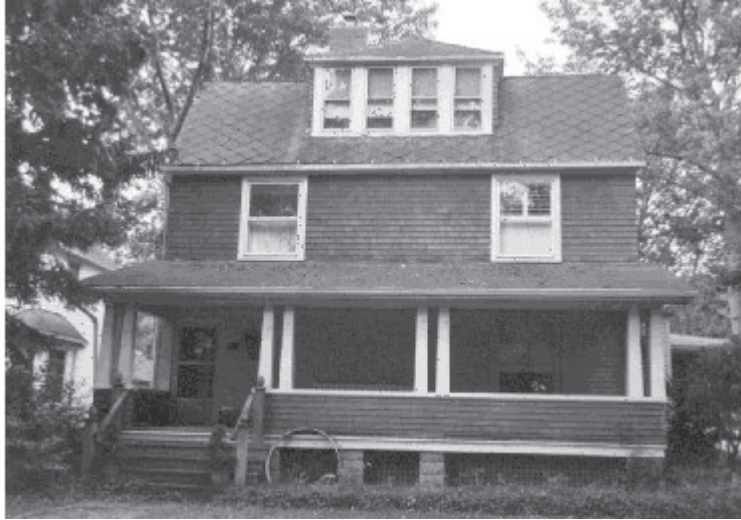
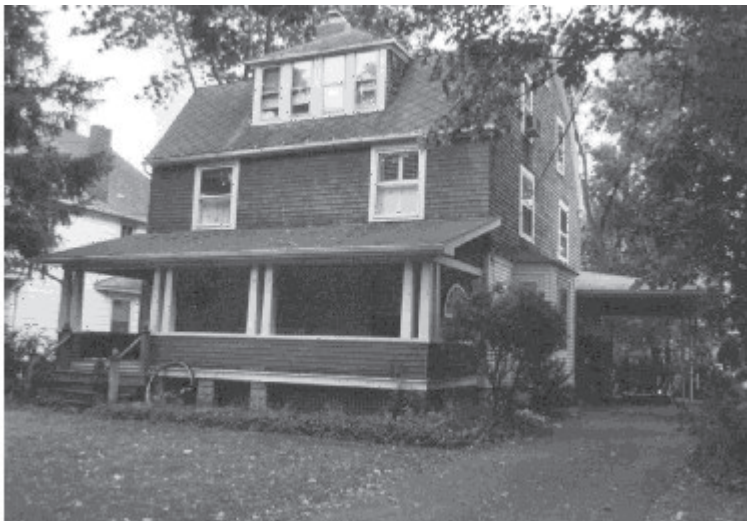
1. No. LOR-1608-21	2. County Lorain	4. Present Name(s)	1. No. LOR-1608-21
3. Location of Negatives	O.H.I.O. Resource Cen		
Roll No. 10	Picture No.(s) 13,14	5. Historic or Other Name(s) Belden House, Junto House Dormitory

42. Further Description of Important Interior and Exterior Features (Continued on Reverse if Necessary)						287 West College Street
<p>This Craftsman house has a Dutch Colonial Revival element in its gambrel roof. The house has a full front porch with a shed roof. The supports are slanted, in pairs and sets of three; they sit on top of walls comprised of wood shingles. Wood steps and railings lead up at the left side of the porch, and square lattice runs below. The door is at the extreme left and one large one-over-one window is at the far right. The second story has two large continued...</p>

one-over-one windows and the hipped-roof dormer has four narrow one-over-ones. The second story of the house is comprised of wood shingles, and the first story appears to be vinyl siding. The windows may be replacements, but the storm windows make this difficult to determine. The west elevation has a large carport connected to the house, which extends over the driveway. A square, projecting bay window at the left side of the first story has a sloping, mansard-style roof. Two one-over-one windows are in the second story and attic. An arched window is located in the gable. The east elevation has a door near the center of the first story, with large, one-over-one windows to its right and two smaller windows to its left. Two windows line up directly above the door, with a decorative wood piece separating one from the other. Two one-over-one windows are located to the left and right of the second story and attic. An arched window is in the gable. The one-story addition at the rear has a door and a shed roof extending from it.
