OHIO HISTORIC INVENTORY

1. No. LOR-1819-21		2. County Lorain		4. Present Name(s)		1. No. LOR-1819-21
3. Location of Negatives O.H.I.O.						
Roll No. 3	Picture No.(s) 6,7	5. Historic or Other Name(s) Johnson House				2. County Lorain

46. Prepared By: Clark, Surovy, Tomazic, Tuohy		47. Organization: O.H.I.O./Oberlin Heritage Center		48. Date Recorded: 08/02/2004

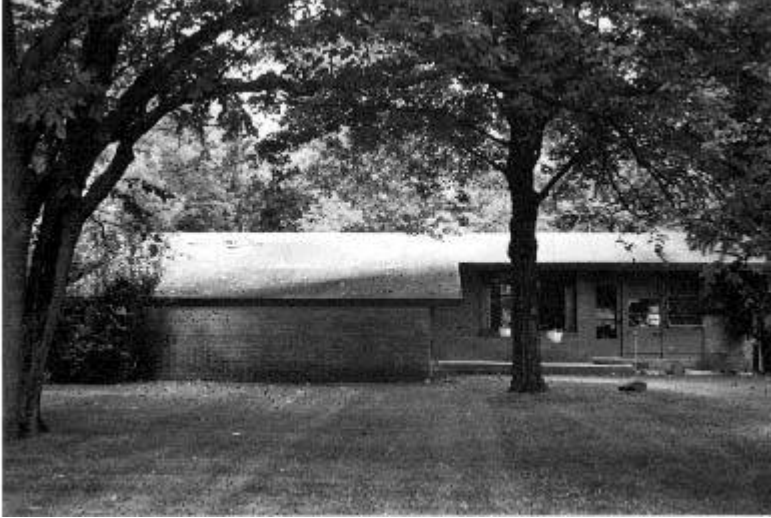
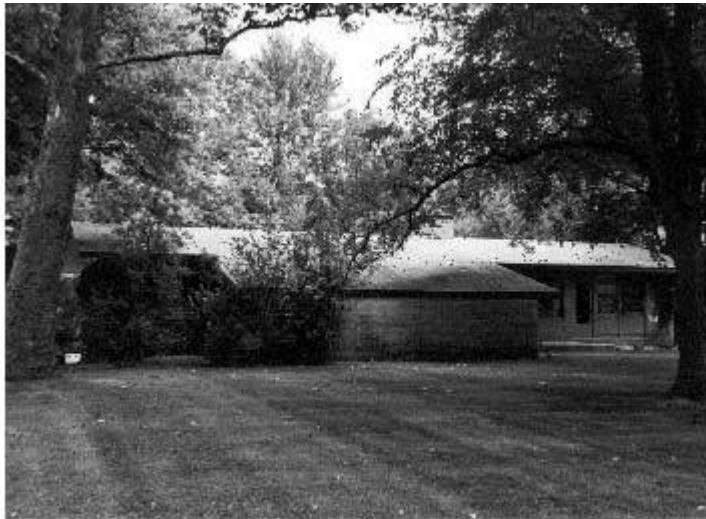
Roll No. **3** | Picture No.(s) **6,7**

42. Further Description of Important Interior and Exterior Features (Continued on Reverse if Necessary)						6. Specific Address or Location 366 W. College Street
<p>This contemporary home is fashioned in the ranch style. The one-story home has a low-pitched gable roof that extends out on front elevation to create a covered carport. The exterior material is brick in a stretcher bond, which is the same material as the carport. The door is located on the right side of the front facade and is flush with the exterior wall. A large picture window is placed on the left side of the front door and four stacked awning windows are located on the left side of the front door. continued...</p>

44. Description of Environment and Outbuildings (See #52)						
<p>The house is on the north side of W. College St. and is the seventh house from the intersection of W.College and Prospect St. The house is in excellent condition and appears to have only a few alterations. The house is surrounded by other well-maintained homes.</p>

windows are to the right. Several large picture windows are located farther down on the front elevation. Several repeated sets of four stacked awning windows appear on the east elevation. Vinyl siding appears to be located under the roof on the east elevation and west elevations. No windows are present on the west elevation. The carport and foliage obscure several facades. The house is rectangular in plan and according to the Lorain County Auditor's property card; the house contains a full basement. A stone chimney is located off-center within the ridge line.
