# OHIO HISTORIC INVENTORY

1. No. LOR-1822-21		2. County Lorain		4. Present Name(s)		1. No. LOR-1822-21
3. Location of Negatives O.H.I.O.						
Roll No. 1		Picture No.(s) 8,9		5. Historic or Other Name(s) Brill House		2. County Lorain

6. Specific Address or Location 52 Edison Street		16. Thematic Associations: Public Safety, Water,		28. No. of Stories Two story		
6a. Lot, Section or VMD Number 0900096102026		17. Date(s) or Period c. 1874-1877		17b. Alteration Date(s) 1994 (Property Card)		4. Present or Historic Name(s)

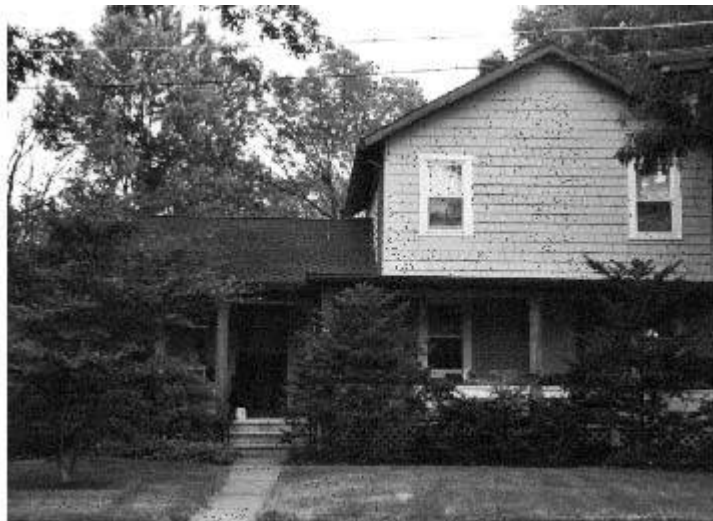
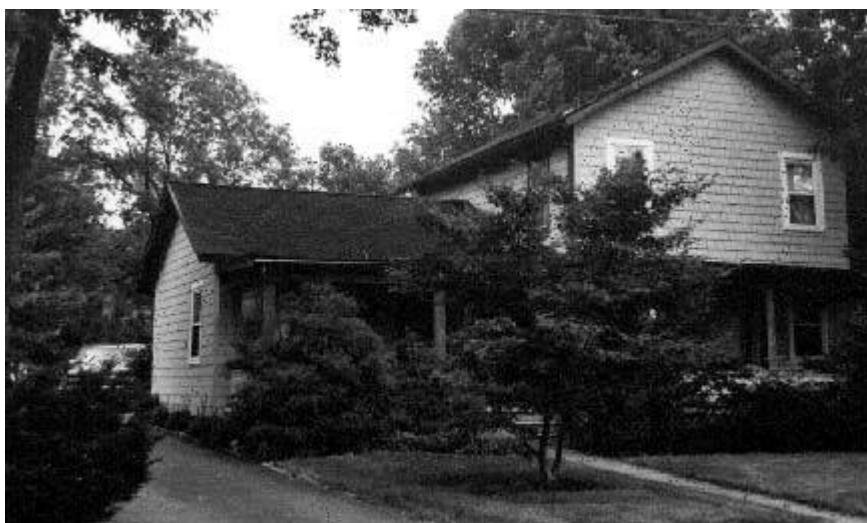
**8,9**

41. Distance from & Frontage on Road Dist: 15' & Frontage: 51'		
42. Further Description of Important Interior and Exterior Features (Continued on Reverse if Necessary)						6. Specific Address or Location 52 Edison Street
<p>This house is an altered Upright and Wing, resembling the Greek Revival style. The exterior of the house is covered in wood shingles. The upright portion of the house is two stories and contains a door, which is not original to the house, near the center, and one-over-one double hung replacement windows flank it. Two one-over-one double hung windows are located on the second story; they are also replacements. The full front porch has a wood continued...</p>

44. Description of Environment and Outbuildings (See #52)						
<p>The house has two non-historic sheds at the rear of the property. The house is in stable condition and is located across from a large, empty lot on a residential street.</p>

51. Condition of Property: <b>Good/Fair</b>	54. Farmstead Plan
52. Historic Outbuildings and Dependencies

shingled wall around the perimeter and simple square supports. On the left half of the front elevation, one-over-one double hung replacement windows flank an off-centered door. The left half is the wing portion of the facade, is one story, and is set back from the upright portion. The upright portion has a front-facing gable, while the wing has a side gable. The west elevation is one story and has a single one-over-one double hung replacement window. The home's rear addition is not visible from the west elevation. The east elevation has one-over-one replacement windows and a one-story addition at the rear, which is covered in vinyl siding.
