# OHIO HISTORIC INVENTORY

1. No. LOR-1830-21		2. County Lorain		4. Present Name(s)		1. No. LOR-1830-21
3. Location of Negatives O.H.I.O.						
Roll No. 5		Picture No.(s) 10,11		5. Historic or Other Name(s) Bebout-Morris House		2. County Lorain

6. Specific Address or Location 134/136 N. Main Street		16. Thematic Associations: United Church of Christ, College, Painting		28. No. of Stories Three story		
6a. Lot, Section or VMD Number 0900075110072		17. Date(s) or Period c. 1894		17b. Alteration Date(s) ca. 1990 (vinyl)		4. Present or Historic Name(s)

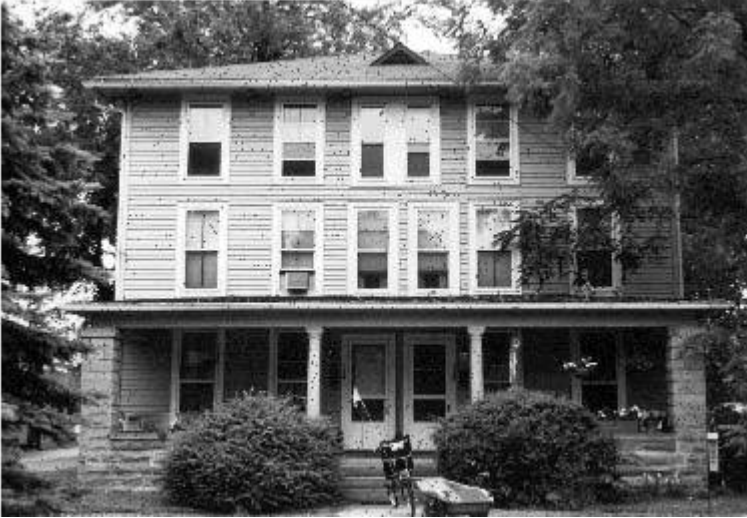
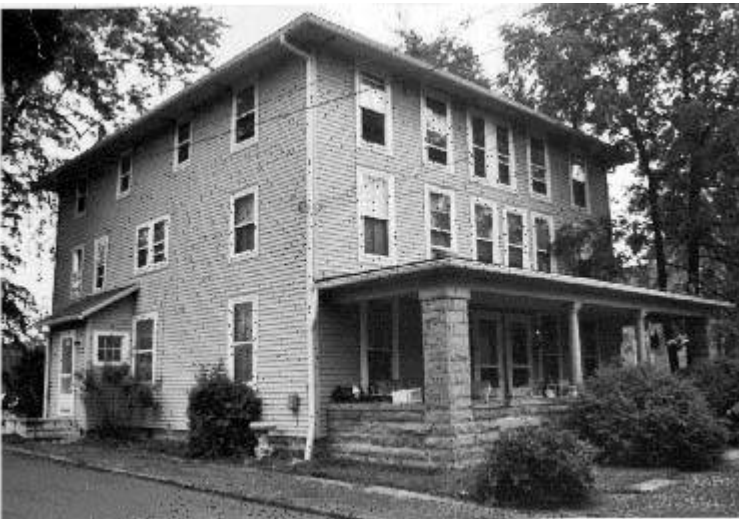
L<sup>No</sup>  
LOR-1830-21

26. Property Acreage .32		38. Building Dimensions 40' x 50'		
		27. Other Surveys		39. Endangered? By What?		
		42. Further Description of Important Interior and Exterior Features (Continued on Reverse if Necessary) This large, altered rental property has a full front porch, which has rock-faced stone supports at the corners and a stonewall around its perimeter. Other porch supports are Doric columns. The front stairs rise at the center of the porch and appear to be sandstone with metal rails. The stairs lead up to double doors, with two, two-over-two double hung windows at the left and right of the doors. The second and third stories have one-over-one and continued...		40. Chimney Placement Unknown

two-over-two double hung windows, in repetition of the six bays of the facade. The one-over-one windows are wood, but appear to have lost their muntins that once made them two-over-two windows. The two center third story windows appear to have been altered, as they do not line up with the other bays and are slightly smaller than the other windows. Decorative brackets run below the roof's eaves, and give the house an Italianate flavor. A small, triangular dormer in the roof contains a vent. The south elevation has a projecting, enclosed entry at the left of the elevation and has a shed roof. A large one-over-one double hung window is located to the entry's right (at the center of the elevation). A smaller one-over-one double hung window is located at the far right of the first story. The second story has five one-over-one double hung windows; the two windows near the center are in a pair. The third story has four one-over-one double hung windows. The north elevation has a repetition of bays and double hung windows, as in the south elevation. An entry towards the right side of the elevation has two steps leading up to it.
