OHIO HISTORIC INVENTORY

1. No. LOR-1841-21		2. County Lorain		4. Present Name(s)		1. No. LOR-1841-21
3. Location of Negatives O.H.I.O.						
Roll No. 2		Picture No.(s) 2,3		5. Historic or Other Name(s) Ornsky House		2. County Lorain

6. Specific Address or Location 312 S. Main Street		16. Thematic Associations: Food Service, Metal Industries,		28. No. of Stories Two story		
6a. Lot, Section or VMD Number 0900095106024		17. Date(s) or Period ca. 1870		17b. Alteration Date(s) 1919, 1940 (Property Card)		4. Present or Historic Name(s)

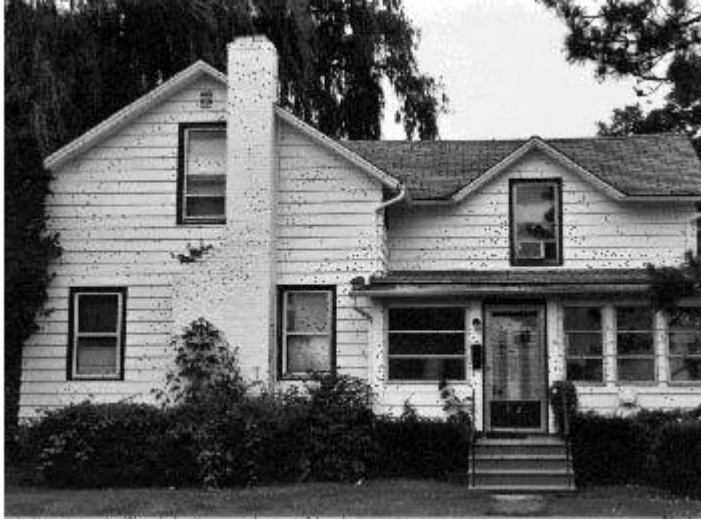
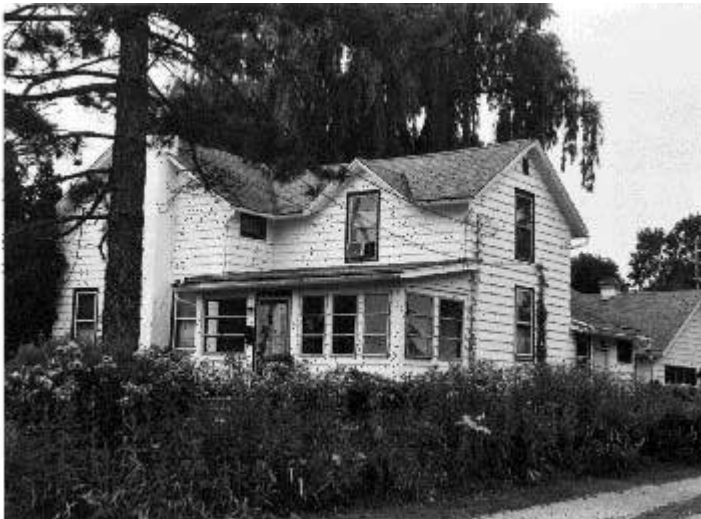
L^{No}
LOR-1841-21

This house is a vernacular Upright and Wing house with an enclosed porch at the right of the main facade. The porch has metal windows and a door left of center, with three triple hung windows to the right and a single triple hung window to the left. Above the porch, a one-over-one double hung window is located at the center is accentuated by a front-facing gable, which intersects the side gable roof. Left of the porch, the front-facing gabled continued...

This house is in stable condition and is located on a state route in Oberlin.

section has an exterior chimney near its center, flanked by one-over-one double hung windows at the first story. A single one-over-one double hung window left of the chimney is in the second story. Cement steps and a metal railing lead up to the front door. The south elevation has two first story windows with metal awnings above them. A very small window with an awning is located at the far left of the second story. A flat-roofed section at the rear of the house projects from the first story and creates the second story porch. The north elevation has a garage visible at the rear of the house, which has been attached through a dogtrot with windows. The main body of the house, at the left of this elevation, has a gabled section with a one-over-one double hung window at the first and second stories. An addition to the right (left of the dogtrot) has a door near the center, and is flanked by windows; this addition is one story.
