# OHIO HISTORIC INVENTORY

1. No. LOR-1729-21		2. County Lorain		4. Present Name(s)		1. No. LOR-1729-21
3. Location of Negatives O.H.I.O Resource Cent						
Roll No. 16		Picture No.(s) 28,29		5. Historic or Other Name(s) Kelner-Meadows House		2. County Lorain

6. Specific Address or Location 147 Morgan Street		16. Thematic Associations: AGRICULTURE, EDUCATION, Law Office		28. No. of Stories Two story		
6a. Lot, Section or VMD Number 0900-095-101-025		17. Date(s) or Period c. 1904-08	17b. Alteration Date(s)	29. Basement? Yes		4. Present or Historic Name(s)

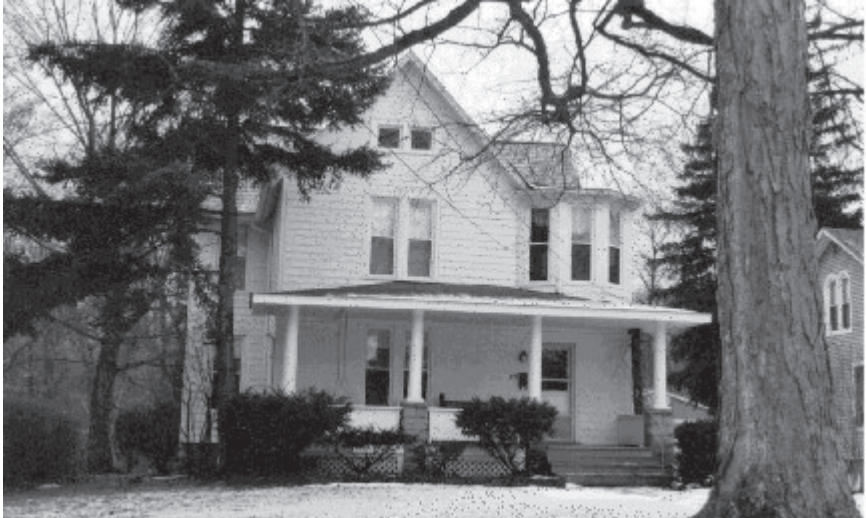
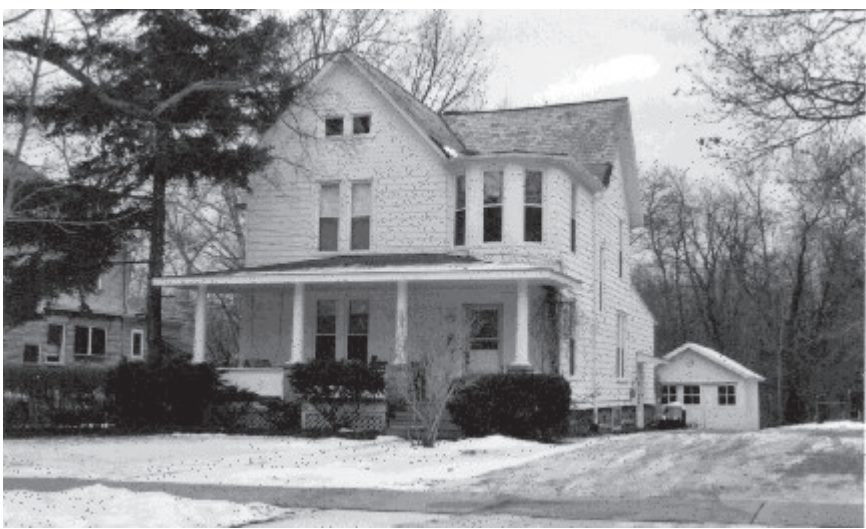
1. No. LOR-1729-21	2. County Lorain	4. Present Name(s)	1. No. LOR-1729-21
3. Location of Negatives	O.H.I.O Resource Cent		
Roll No. 16	Picture No.(s) 28,29	5. Historic or Other Name(s) Kelner-Meadows House

round wood shingles. The remainder of the exterior is made of square shingles. The west elevation has a door in the addition at the far right, which is shaded by a shed hood. A pair of one-over-one windows is situated to the left of the door. A one-over-one window is between the first and second stories, near the center, and another one-over-one window is at the left and right of the second story. The attic has rounded shingles and a square window. The east elevation features a gabled section near the center that has pairs of one-over-one windows at the first and second stories; the same windows are in the portion to the right. A one-over-one window is also located in the addition at the far left of the elevation. The gable contains a square window in the attic and rounded shingles.
