OHIO HISTORIC INVENTORY

1. No. LOR-1761-21		2. County Lorain		4. Present Name(s)		1. No. LOR-1761-21
3. Location of Negatives O.H.I.O. Resource Cen						
Roll No. 15		Picture No.(s) 30,31		5. Historic or Other Name(s) Ries House		2. County Lorain

6. Specific Address or Location 291 Oak Street		16. Thematic Associations: Visual Arts, College,		28. No. of Stories Two story		
6a. Lot, Section or VMD Number 0900-085104-001		17. Date(s) or Period c. 1940		17b. Alteration Date(s)		4. Present or Historic Name(s)

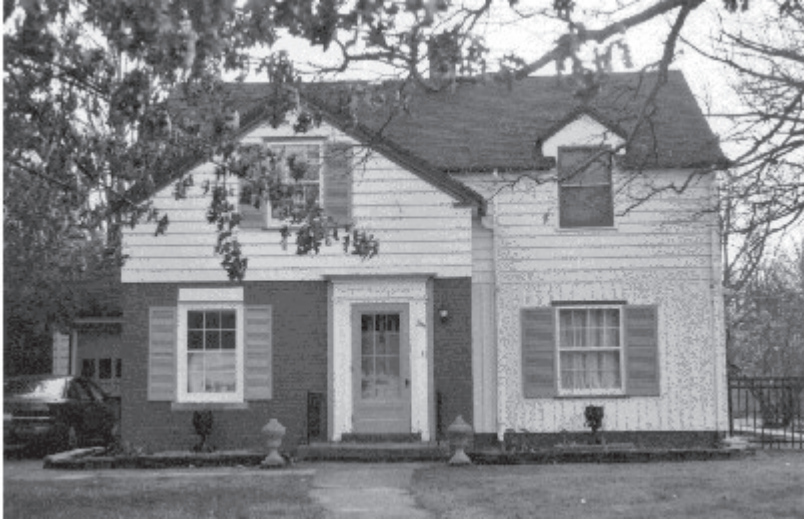
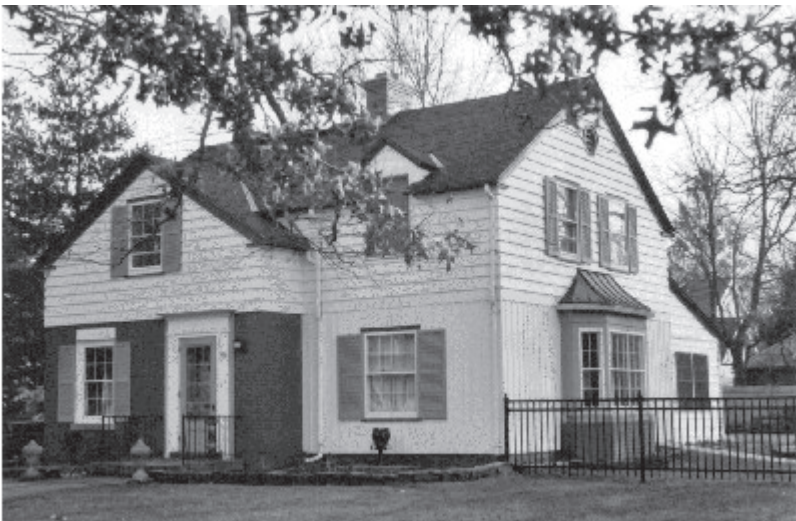
1. No. LOR-1761-21	2. County Lorain	4. Present Name(s)	1. No. LOR-1761-21
3. Location of Negatives	O.H.I.O. Resource Cen		
Roll No. 15	Picture No.(s) 30,31	5. Historic or Other Name(s) Ries House

41. Distance from & Frontage on Road Approx. 35'		
42. Further Description of Important Interior and Exterior Features (Continued on Reverse if Necessary)						6. Specific Address or Location 291 Oak Street
<p>This Colonial Revival house has a plan that is a variation of the Cape Cod, the difference being its single dormer and asymmetrical facade. The facade has a projecting gabled portion that comprises the left half. A six-over-six window with shutters is located to the far left, and the door to the right of the projecting portion has molded wood panels and decorative windows within it. The door has an entablature and pilasters surrounding it. The continued...</p>

first story of the gabled portion is comprised of painted brick, and the upper half is wood clapboard siding. A six-over-six window with shutters is located in the gable. Right of the gabled portion, the first story is comprised of board and batten siding and the second story is wood clapboard. An eight-over-eight window at the first story has shutters, and a gabled wall dormer is located above. The chimney is comprised of painted brick, and sits in the middle of the roof's ridgeline. A one-car, attached garage is situated at the far left, and is recessed back from the house; it has a wood clapboard exterior. The west elevation contains a projecting bay window, which has a metal, standing seam roof. The bay also has four-over-four windows at its cutaway sides and a window with many lights on its flat side. Two six-over-six windows with shutters are in the second story, with a round, louvered vent in the gable. An addition at the rear of the house has a shed roof, aluminum siding, and a pair of eight-over-eight windows. The east elevation is comprised of board and batten at the first story and wood clapboard in the second. The door to the far left, near the garage, has a small, six-over-six window to the immediate right, and another to the far right, with shutters. The second story has two six-over-six windows with shutters and a circular louvered vent in the gable.
