OHIO HISTORIC INVENTORY

1. No. LOR-1762-21		2. County Lorain		4. Present Name(s) Formed Metal Products Inc. Building		1. No. LOR-1762-21
3. Location of Negatives O.H.I.O. Resource Cen						
Roll No. 12		Picture No.(s) 02,03		5. Historic or Other Name(s)		2. County Lorain

6. Specific Address or Location 185 North Oberlin Road		16. Thematic Associations: MANUFACTURING/INDUSTRIAL, ,		28. No. of Stories One story		
6a. Lot, Section or VMD Number 0900-078-000-027		17. Date(s) or Period c. 1950		17b. Alteration Date(s)		4. Present or Historic Name(s) Formed Metal Products Inc. Building

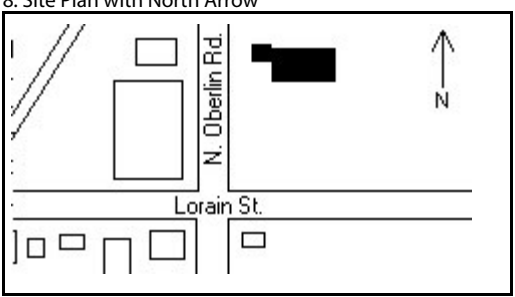
8. Site Plan with North Arrow

41. Distance from & Frontage on Road Approx. 25'		
42. Further Description of Important Interior and Exterior Features (Continued on Reverse if Necessary) This Quonset is comprised of a small original structure that is situated to the front and left of a much larger, contemporary Quonset-style addition. The front facade of the original building is very simple. The solid, plain door is located at the center of the elevation, which is the flat end of the building. A metal railing leads down the steps that reach the door, which is below street level. Small one-over-one windows flank the door, and they continued...						6. Specific Address or Location 185 North Oberlin Road

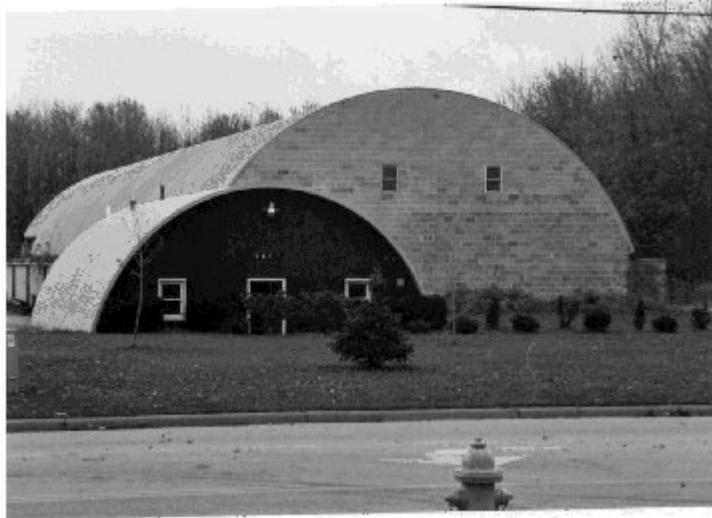
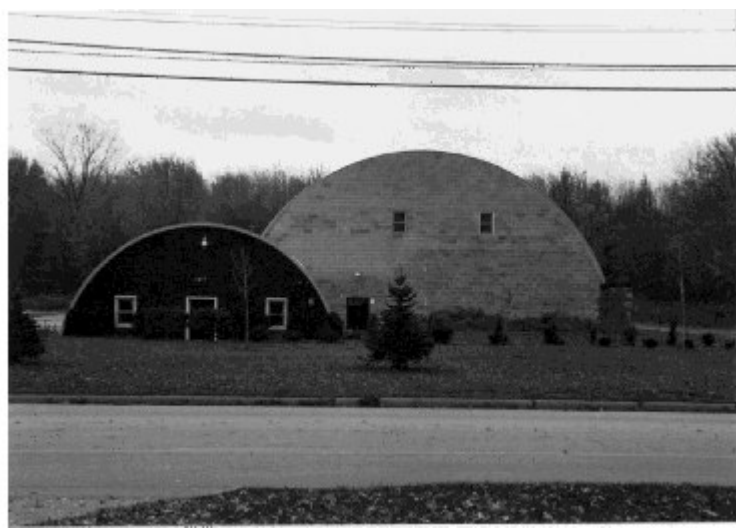
51. Condition of Property: **Good/Fair**

have vertical metal bars over them. A light is fixed at the center of the arch. The exterior of the end is comprised a wood sheets. The building has no chimney, rather, pipes rise from the roof. The roof is made from an undetermined material; its corrugated surface is painted and decorated with hash marks. No other ornament is visible on the original structure. The two-story, larger Quonset is attached to the southeast corner of the smaller building. This addition, which appears to be under construction, has small one-over-one windows in the second story. A door is the only feature in the first story, and it is located to the far left. This door also begins below street level. A wall extends approximately two feet up and six feet from the right corner of the facade; a total of nine walls project from the south elevation below the roof. A concrete exterior runs below the roof, between each projecting wall.
