OHIO HISTORIC INVENTORY

1. No. LOR-1922-21		4. Present Name(s) Bailey House		LOR-1922-21
2. County Lorain		5. Historic or Other Name(s) Bailey House		
6. Specific Address or Location 208 North Professor		19a. Design Sources		Lorain
6a. Lot, Section or VMD Number 0900075106063		20. Contractor or Builder

1. No. LOR-1922-21	4. Present Name(s) Bailey House
2. County Lorain	5. Historic or Other Name(s) Bailey House

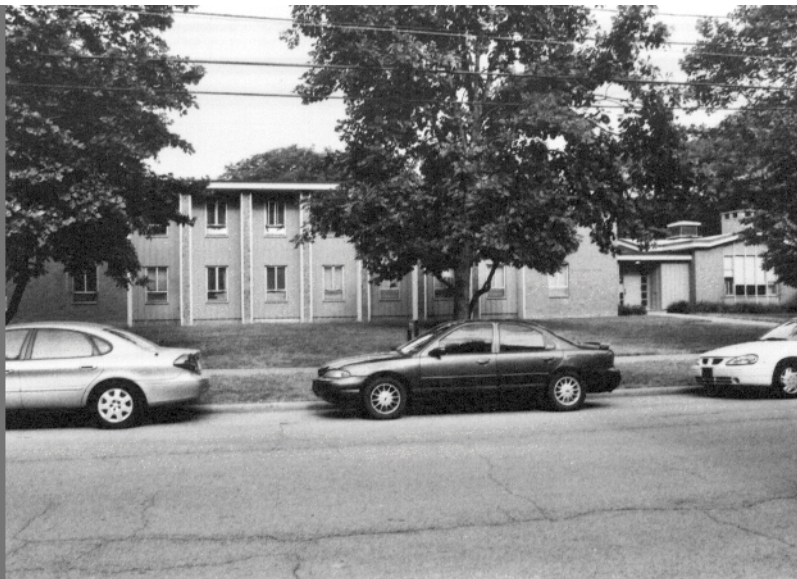
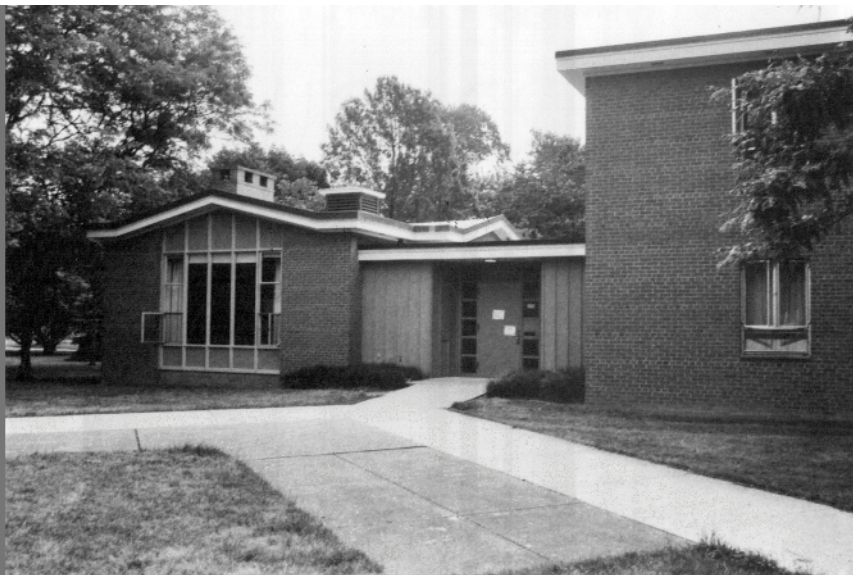
53. Affiliated Inventory Numbers Historic (OHI)		
		Archaeological (OAI)		208 North Professor
42. Further Description of Important Interior and Exterior Features (Continued on Reverse if Necessary)				
<p>This building is among several campus dormitories constructed in 1968 & designed by architects Moore & Hutchins. Its twin, Zechiel Hall, stands just across North Quad to its west, & differs only in the color of the board & batten siding. The main/east facade, which faces Professor St., has 3 main sections: a 2-story section on the left, which contains student rooms, a 1-story section with an east-facing gable roof on the right, which contains a lounge, & an entry with a shorter, 1-story flat roof which links the two. The 2-story section is both wider & longer than the other sections, & thus projects further forward. It has large brick portions at each corner with one window in each story; these flank 7 recessed bays of board & batten siding. Each bay also has a window in each story, separated by 6 brick piers lined with cement. All windows in the 2-story section include 2 casement windows atop a hopper window. The roof of this section is mostly flat, but slopes upward to form a small side gable in the center. To the right of the 2-story section is the entry, which includes a plain door surrounded by sidelights & a transom & flanked by board & batten walls. The continued...</p>

1-story section to the right contains a gable in the center. Beneath the gable & between two sections of brick a large window has filled panels that form its top & bottom border. 3 small casement windows on either side flank the large rectangular pane in the center. Set further back to the right, a small brick section has a narrow line of windows just below the chimney, situated on the ridgeline. The north elevation contains no windows - 2 brick sections with flat roofs flank a gabled center section, which juts out from the sides. At the ridgeline 2 decorative absences of brick are visible in the chimney, creating the appearance of brick 'pillars' supporting a hood. The chimney partially obscures the view of the 2-story portion's 2nd story northern elevation. As the building's west elevation mirrors the east, so does this portion's north elevation mirror that of the south. Facing south beneath the flat part of the roof are brick portions on the outside with windows in each story. Between these, brick & board & batten sections, with a door on the lower right, flank a pattern of alternating filled panels, square hopper windows & taller textured glass windows that extend from the ground to the roofline of the central gable.
