OHIO HISTORIC INVENTORY

1. No. LOR-1772-21		2. County Lorain		4. Present Name(s)		1. No. LOR-1772-21
3. Location of Negatives O.H.I.O. Resource Cen						
Roll No. 4		Picture No.(s) 14, 15		5. Historic or Other Name(s) Kenney House		2. County Lorain

6. Specific Address or Location 10 South Prospect Street		16. Thematic Associations: Temperance, General Mixed Farm, Health Care		28. No. of Stories Two story		
6a. Lot, Section or VMD Number 0900-084-107-025		17. Date(s) or Period 1867		17b. Alteration Date(s)		4. Present or Historic Name(s)

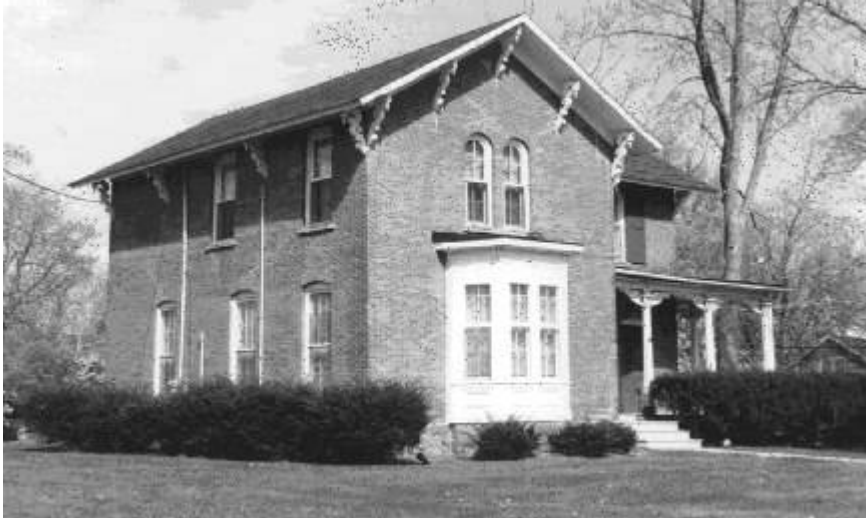
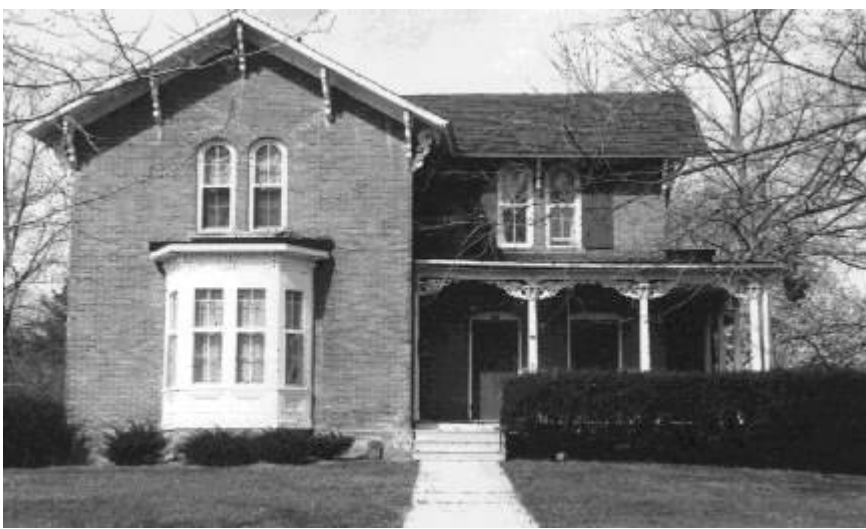
Roll No. **4** | Picture No.(s) **14, 15**

42. Further Description of Important Interior and Exterior Features (Continued on Reverse if Necessary)						6. Specific Address or Location 10 South Prospect Street
<p>This is a good example of a brick Italianate Gabled Ell house in Oberlin. The front-facing gable is located at the left side and it contains a projecting bay at the first story, made from wood. The bay features four-over-four windows with molded wood panels below & wood arches above. Its flat roof has brackets and a Greek key pattern below. The second story has a narrow pair of arched, four-over-four windows. The exterior bricks follow the arch continued...</p>

of the windows. The home' s wide, overhanging eaves have carved, scrolling brackets. At the right side of the elevation, the porch wraps to the north elevation. The supports have chamfered edges scrollwork between each support, below the roof. Two tall windows are located at the porch, which have closed shutters hiding them. The exterior bricks follow the flat arches of these windows. Above the porch, the second story features a pair of narrow, arched four-over-four windows, with shutters on their exterior ends. The windows of this house have stone sills. The south elevation has three windows at the first story and two at the center and right side of the second story; all are six-over-six with flat arches. The exterior brick follows the arches, and the windows have stone sills. A bricked-in, square window is located at the right side of the second story. Brackets are visible below the roof' s eaves. At the north elevation, a gable end is located at the left side. A pair of arched windows matches those above the porch on the main facade. A window with closed shutters is located at the left side of the first story and a door is to the right. Both the door and window have flat arches. Four six-over-six windows with flat arches are featured in the wing, which extends to the right; they have flat arches and shutters. The addition is indicated by its lack of brackets below the roof. At this elevation, the basement windows have arches.
